## Pilot remediation and thermic immobilization of sediments of New Merwede River

L.A. van der Kooij, DHV Environment and Infrastructure BV, P.O.Box 1076, 3800 BB Amersfoort

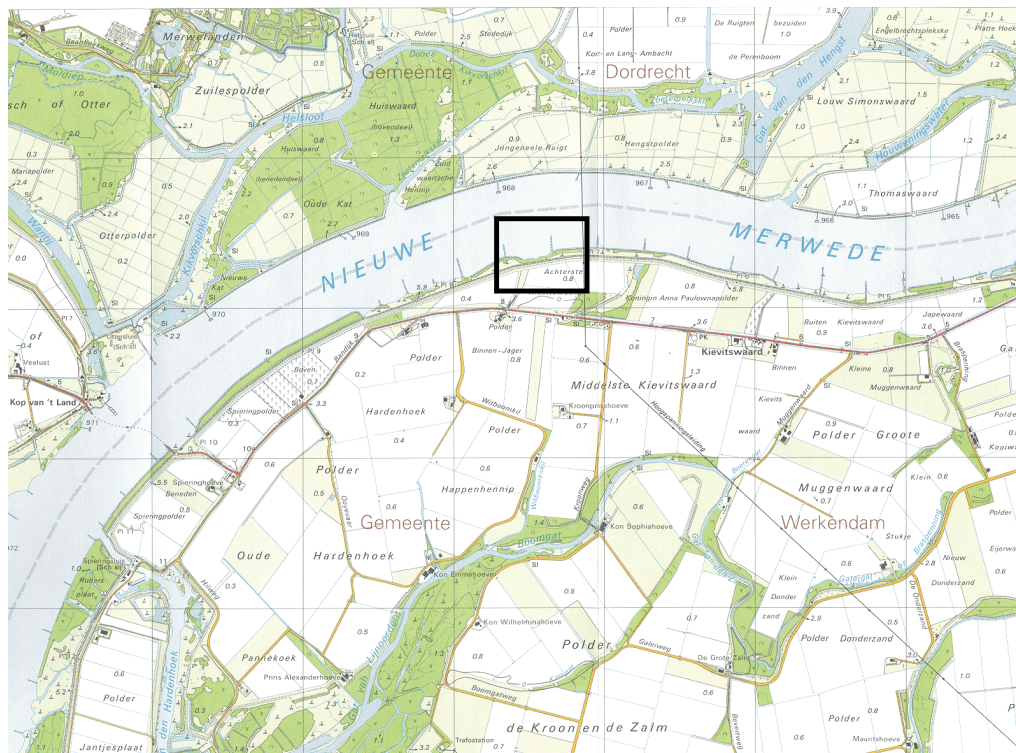
Figure 1 Map of New Merwede River. The rectangle marks the area of the pilot remediation.

A pilot projects was conducted by the Netherlands Directorate-General for Public Works and Water Management (*Rijkswaterstaat*) in preparation for the large-scale clean-up operation. This project involved a groyne section in the New Merwede River (*DHV*, ref. 2). Figure 1 contains a map of the area.

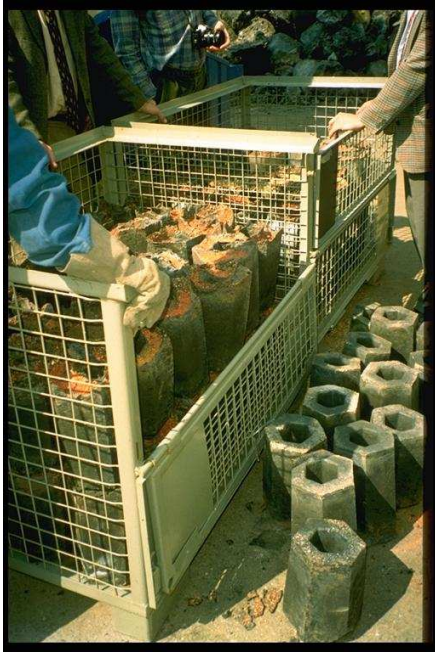
Figure 2. Basalt made out of dredging spoil

The objective of the thermic immobilization was to make material that could be used in civil works. This was done by separation the spoil into a sand and a sludge fraction. The sand fraction could be used as foundation in the road building. The sludge fraction had further been processed:

- dewatering and drying the material to about 95% dry solid
- melting the dried sludge and adding of materials to lower the melting point (about 1.400 °C). After cooling down basalt had been formed.

In this way about 95% of the material could be reused as sand or basalt.

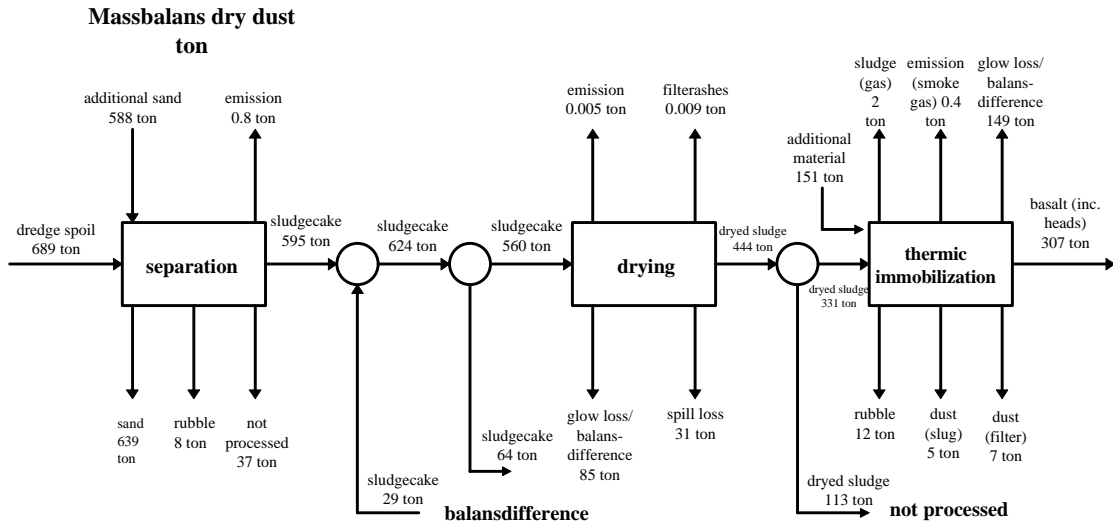
Figure 2 shows the processing route and mass balance of the dry material of the dredging spoil.

Figure 2. Processing route and mass balance of the dry material in the dredging spoil.

After sand separation and drying, 304 tonnes of immobilization product was extracted from 274 tonnes of dried silt and 125 tonnes of additives. Calcining caused the loss of 75 to 100 tonnes, 75% of which originated from the sludge (DHV, December 1996, ref. 2).

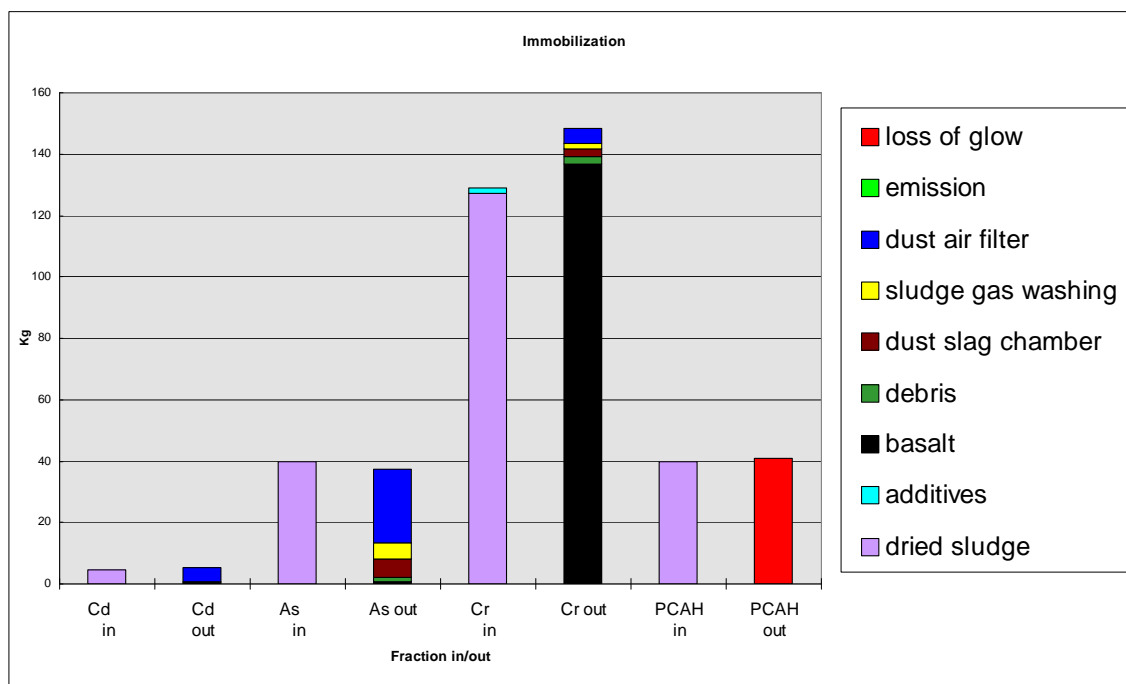
The contaminations appeared to take different routes. This is shown in figure 3 for cadmium (Cd), arsenium (As), chromium (Cr) and polycyclic aromatic hydrocarbons (PCAH).

Figure 3. Routes of contaminants during the process of thermic immobilization.

More than 95% of the relatively volatile compounds, such as cadmium, lead, zinc and arsenic, evaporated and ended up as deposits in air ducts, filter residues of the air purification system and silts of the wet gas scrubbing. PAH almost completely disappeared as a result of scorching. Only chromium and copper were found to have remained, practically intact, in the final products. Table 2 (ref. 1) gives a summary of the results of the materials analysis and leaching tests.
